**WEST VIRGINIA DEPARTMENT OF ENVIRONMENTAL PROTECTION  
WV/NPDES CONSTRUCTION STORMWATER PERMIT**

<b>FACILITY NAME:</b>	Raleigh County Elementary School			<b>REG. #</b>	<b>EXPIRE DATE:</b>
<b>PERMITTEE</b>	RALEIGH CNTY BD OF ED			WVR108335	1/3/2018 Extended: 6/30/2018
<b>ADDRESS/PHONE:</b>	Attn: ROD LIVELY, DIR OF FAC & MAIN 151 CRANSTON DR BECKLEY, WV 25801 3042564565				
<b>LOCATION:</b>	37° 43' 31.9" N, 81° 15' 16.30" W			<b>Entry Date/Time:</b>	5/1/2018 0925
<b>COUNTY:</b>	Raleigh			<b>Exit Date/Time:</b>	5/1/2018 1130
<b>Site Representative /Phone</b>	Johnny Blair-Radford & Radford Brett Hunsucker- PCS			<b>PHOTOS</b> <input checked="" type="checkbox"/>	
<b>CO-PERMITTEE:</b>				<b>ADDRESS:</b>	
<b>SITE OPERATOR:</b>	Radford & Radford Inc.			<b>ADDRESS:</b>	860 Ragland Road, Beckley WV 25801
<b>PERMITTED ACREAGE</b>	15	<b>WEATHER:</b>	Clear	<b>LAST INSPECTION:</b>	n/a
<b>RECEIVING STREAM(S)</b>	Shockley Branch/Camp Branch/Marsh Fork/Big Coal River				<b>NOV: 1</b>
<b>Regular Mail</b> <input type="checkbox"/> <b>Certified Mail</b> <input checked="" type="checkbox"/>		<b>Tracking #</b>

STATE OF WEST VIRGINIA  
Department of Environmental Protection  
Environmental Enforcement

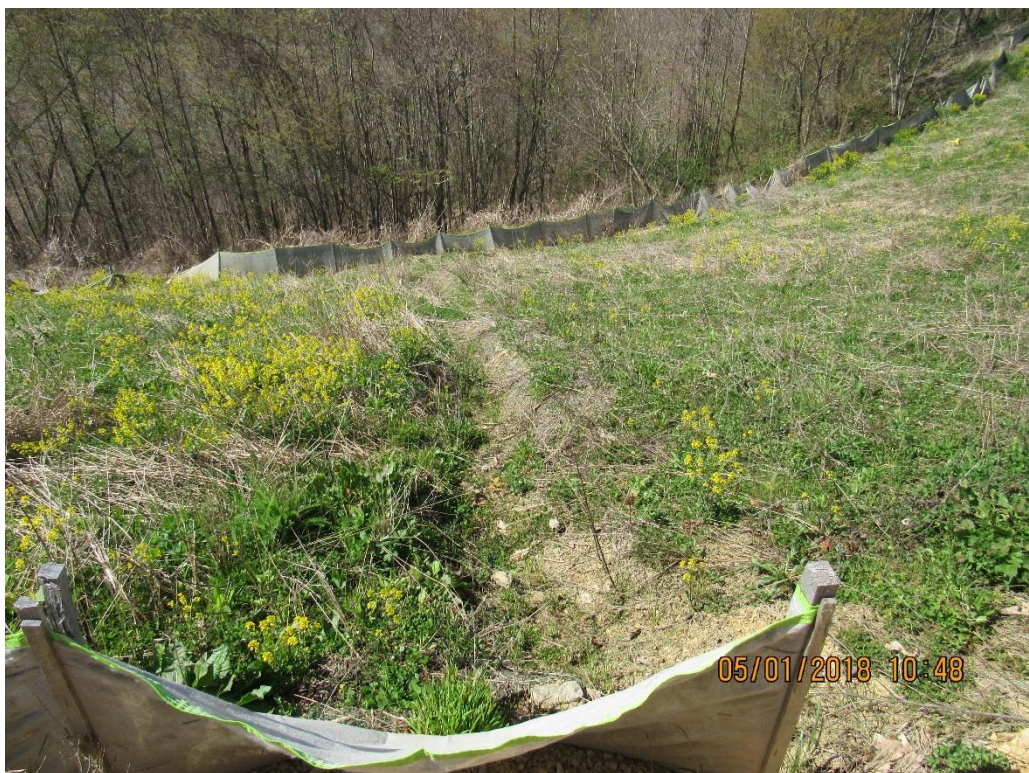
- 14. Southern slope was left unprotected in several areas creating erosion gullies. Diversion ditch was inappropriately cut to allow water to flow uncontrolled down slope, outlet from drainage area under amphitheater had no protection allowing water to flow uncontrolled down slope, location of pump station pad had no controls with sediment delta at terminus. (Photos 25-27)

- **Section G.4.e.2.A.ii.f. - Permittee has failed to protect fill slopes-outlet to amphitheater drainage was not protected and 'cuts' were made into diversion ditch sending water down slope without protection. (Photos 25-27)**

Photo 27: Erosion gully from Photo 26.

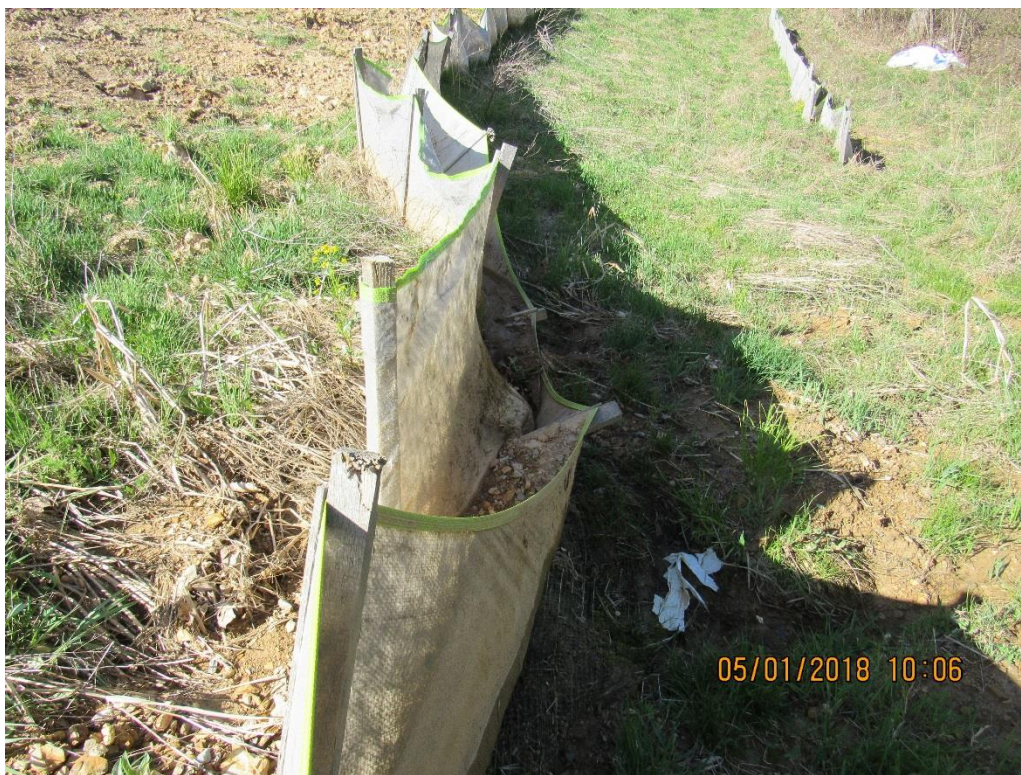
- 19. Evidence of sediment laden water leaving the site was observed at 2 locations. Sediment deposits observed on north side of site from silt fence failure and at sediment basin outlet. (Photos 28-34)

- **Section G.4.e.2.A.ii.j - Permittee has failed to prevent sediment-laden water from leaving the site without going through an appropriate device- on northern side of side where perimeter fencing failed and on western side of site at outlet of sediment basin. (Photos 28-34)**

Photo 28: Silt fence compromised allowing sediment laden water to leave the site on north side of site.

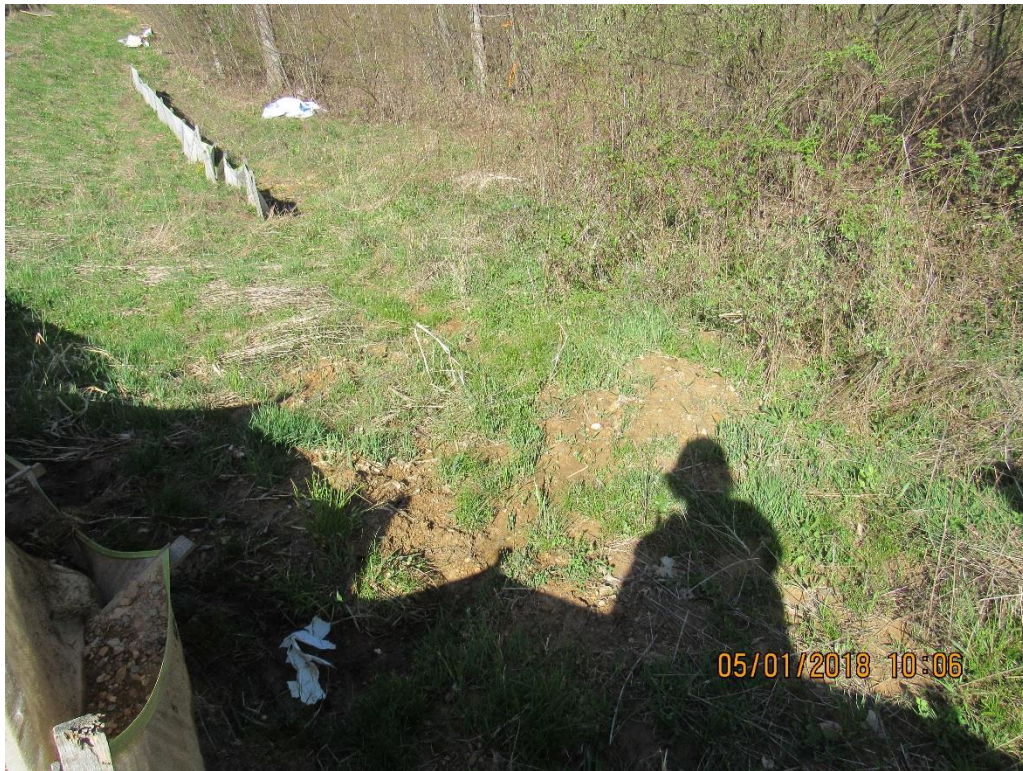
Photo 29: Sediment deposits downslope of compromised silt fence from Photo 28.

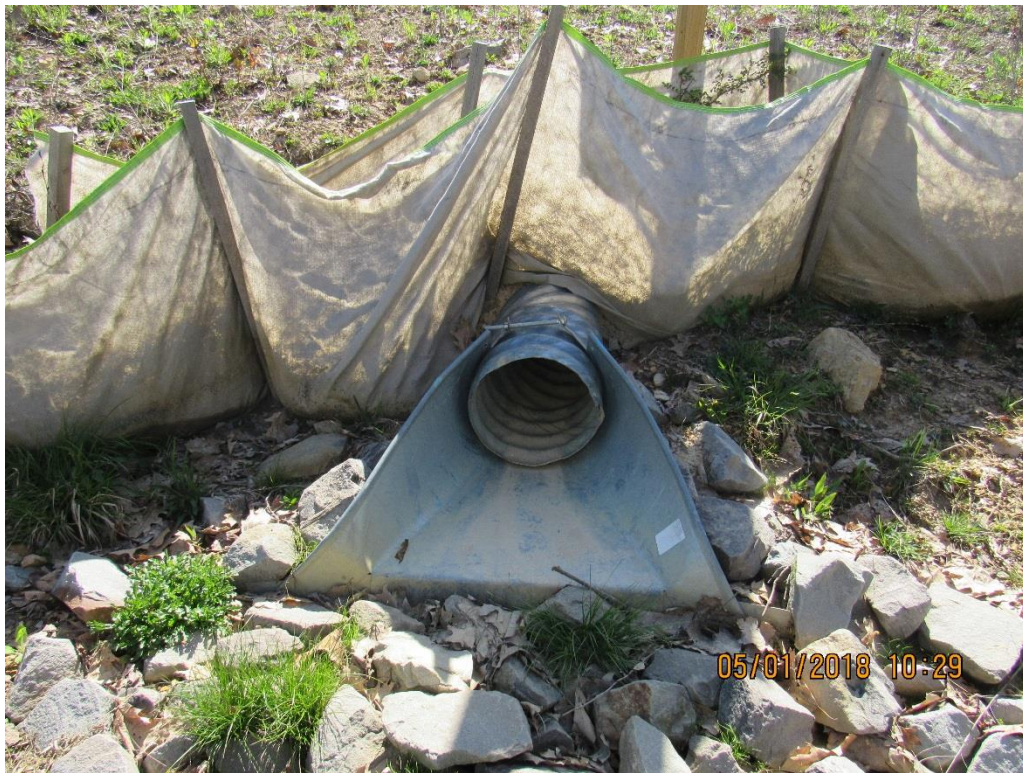
Photo 30: Sediment deposits on outlet of sediment basin.

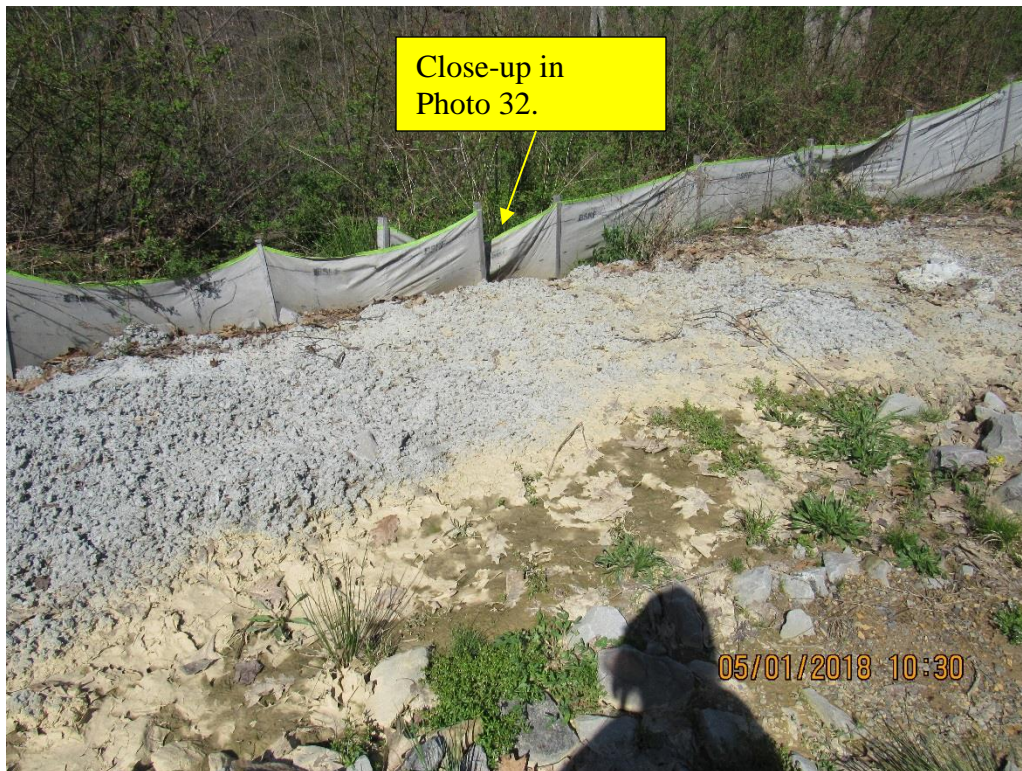
Photo 31: Sediment deposits on stone ring around sediment basin outlet.

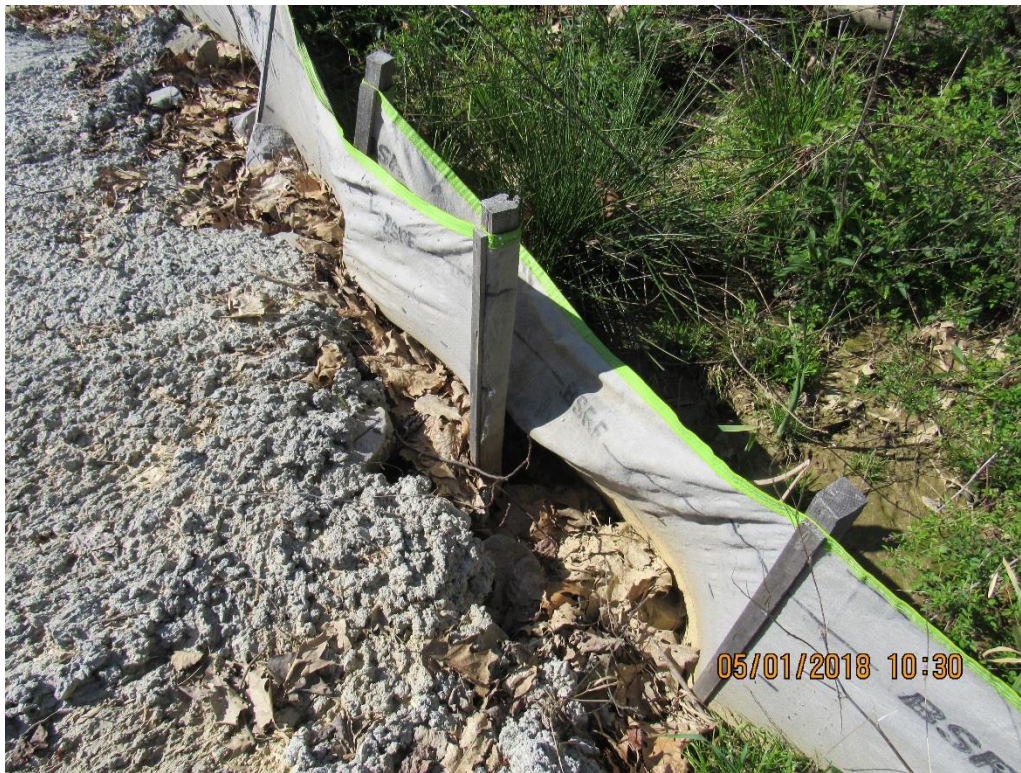
Photo 32: Close-up on notated location in Photo 31 with sediment deposits in perimeter fencing breach.

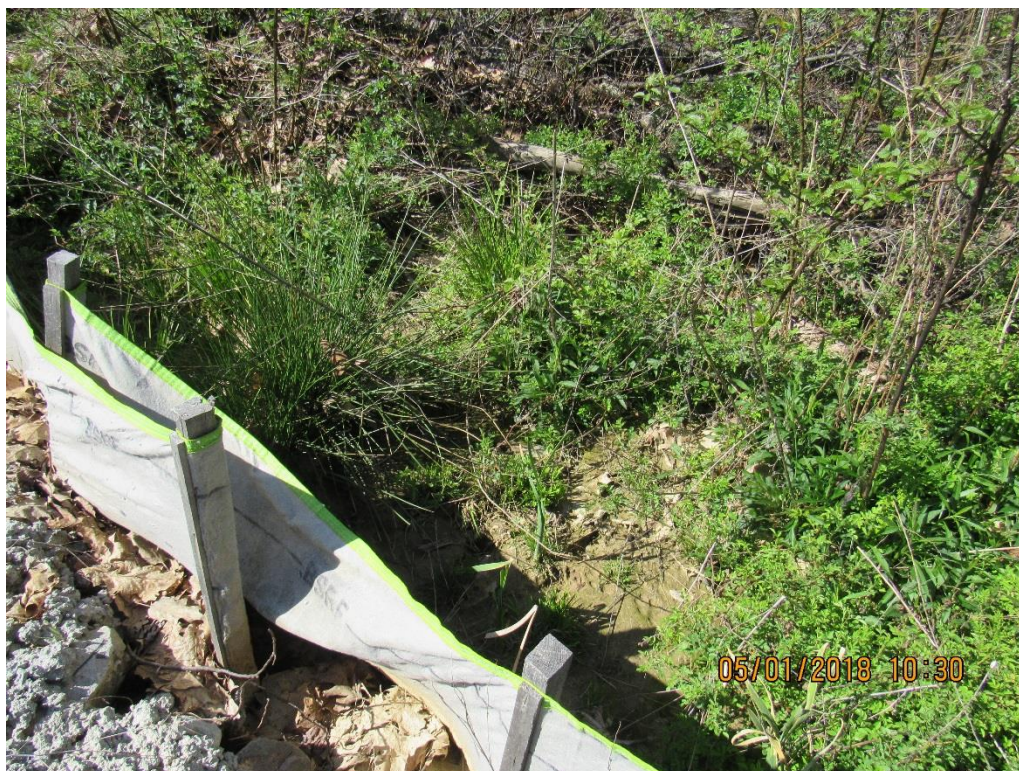
Photo 33: Sediment deposits downslope of perimeter fencing from Photo 32.

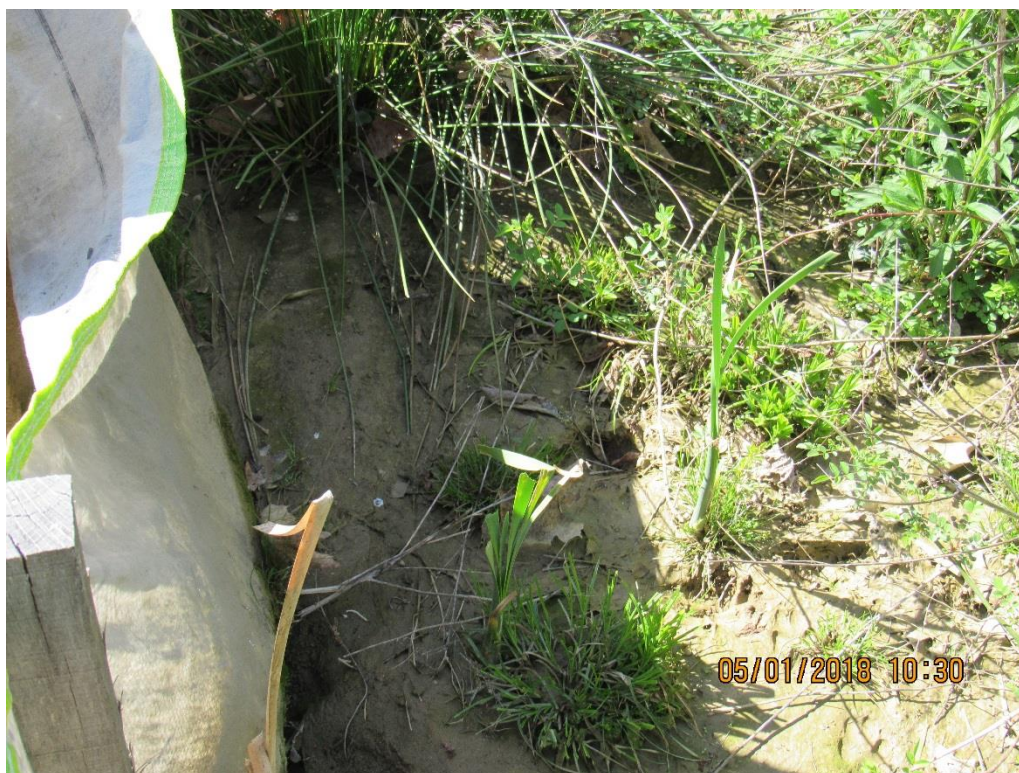
Photo 34: Sediment deposits downslope of sediment basin outlet.
